"crack on the pavement slab of the terrace"

SnapClaim annexure v0.3.0

mode: ABSOLUTE (calibrated) · generated: 2026-11-04T13:48:56.622Z

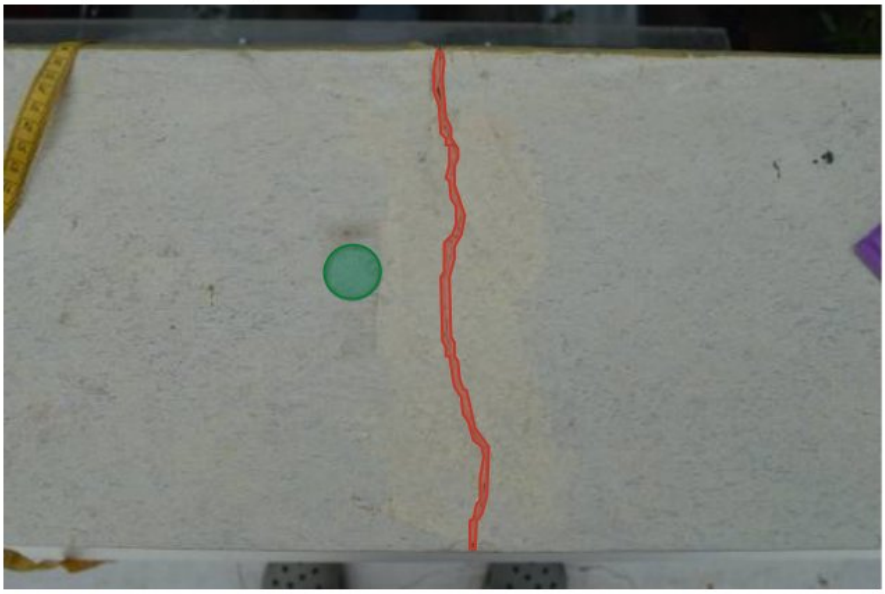
Figure 1 - captured photo, full frame

Crack length: 232 mm [R005] (Confirmed)
Crack width: 3.2 mm [R006] (Unverified - no width ground truth)
Surface affected: 0.73 % [R002] (Confirmed)
Area: 7.48 cm2 [R004] (Confirmed)
Severity: significant [R007] (Confirmed)

On the pavement slab of the terrace, a significant crack covers 0.73%.
